Technical Bulletin

Product Line: Bambi

Models: Bambi Bucket 2024-4453

Subject: Medium Tripline Design Change

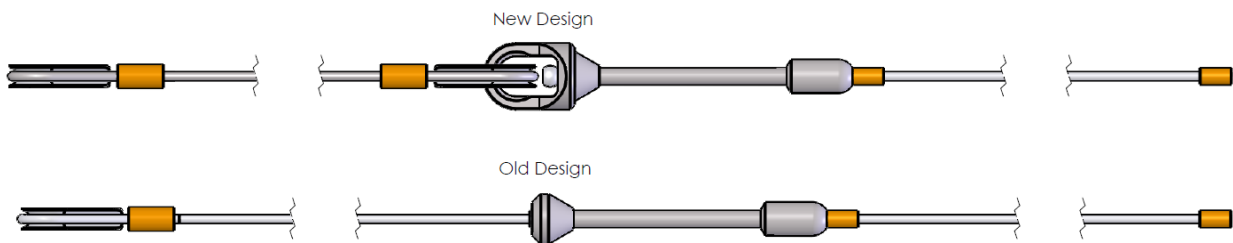
Triplines failing immediately below the bullet assembly has been a recurring issue on medium Bambi Buckets. The root cause on medium buckets is believed to be the cable flexing during take-off and landing. A new design allows the cable to pivot freely immediately after the bullet to eliminate this issue.

The new design, 013057, will replace 005334. The new design is a direct replacement, and does not require any additional modification.

New triplines made by SEI will use the new design. Customers with the old design should continue to use those triplines if they have not encountered problems with them.
