Technical Bulletin

Product Line: Bambi

Models: Bambi MAX Bucket 1518-HL9800

Subject: Cam & Cable Drum Change

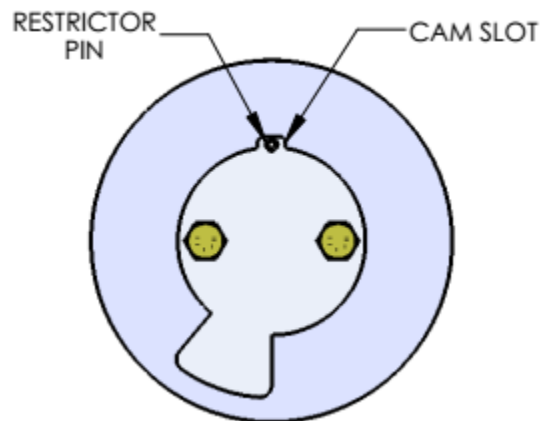
Over adjustment of the valve cam in the clockwise direction can cause stretching of the drive cable. When the valve is opened, the slack in the cable snaps taut. This can lead to premature cable failure.

The cable drum has been changed to include a restrictor pin in the front face. The cams have been changed to include a slot which fits the restrictor pin and prevents over adjustment of the valve position.

The older revisions of the cable drum and cam are not compatible with the newer versions without modification. If you are not experiencing problems with cable failures, it is not necessary to upgrade to the newer system.
