# Technical Bulletin

**Product Line:** Bambi

**Models:** Bambi Bucket 5566-HL9800

**Subject:** Large Tripline Design Change

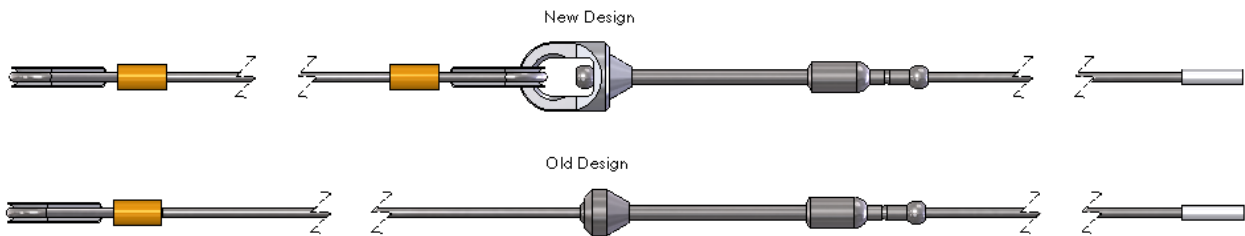
Triplines failing immediately below the bullet assembly has been a recurring issue on large Bambi Buckets. The root cause is believed to be the cable flexing during take-off and landing. A new design allows the cable to freely pivot immediately after the bullet to eliminate this issue.

Old Design		New Design	
Part #	Description	Part #	Description
005333	TRIPLINE, 5566-7590	013058	TRIPLINE, FLEX, 5566-7590
005336	TRIPLINE, HL4000-HL9800	013059	TRIPLINE, FLEX, HL4000-HL9800

The new design is a direct replacement and does not require any additional modification.

New triplines made by SEI will use the new design. Customers with the old design should continue to use those triplines if they have not encountered problems with them.
