# Technical Bulletin

**Product Line:** Bambi

**Product:** Standard Bambi Bucket, Bambi MAX Bucket, Bambi Torrentula Bucket

**Subject:** Washers added to medium IDS assemblies

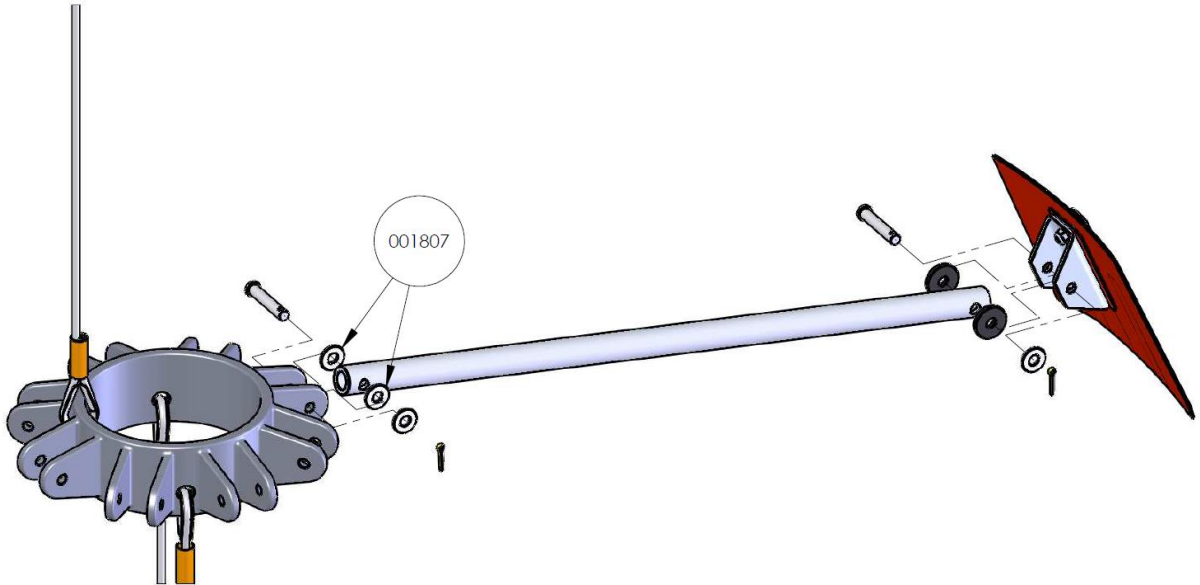
Figure 1 - Washer location

An issue has been reported where suspension lines were catching on the IDS hub when pulling out of a dip, which led to additional damage to the bucket shell. This happened because the suspension line became lodged between the spoke and the IDS hub. There is the potential for this to occur on all buckets using the medium size IDS hub. However, the spoke must be forced to one side to create enough clearance for the suspension lines to fit between the spoke, and the ear of the IDS hub.

To eliminate this issue, new medium IDS assemblies will include sixteen (16) 5/16" nylon washers (Part # 001807), which will center the spokes in the IDS hub and prevent the suspension lines from lodging themselves between the hub and the spoke.

Customers with medium IDS assemblies are advised to install washers between the spokes and the IDS hub to prevent this issue from occurring. See Figure 1 for reference.
